FLUSHED OUT

Unravelling the Labyrinth of Public Toilets in Bengaluru

A Tale of Access, Equity and Quality

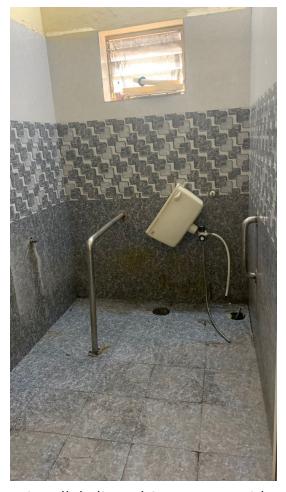
A stall dedicated for persons with disabilities which did not have a toilet.

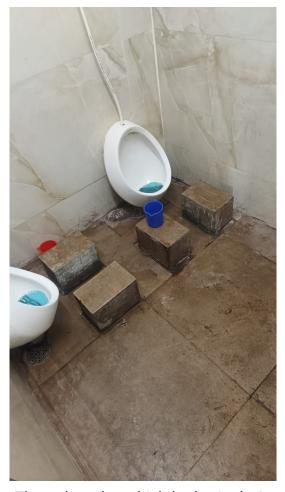
The only toilet which had urinals for children.

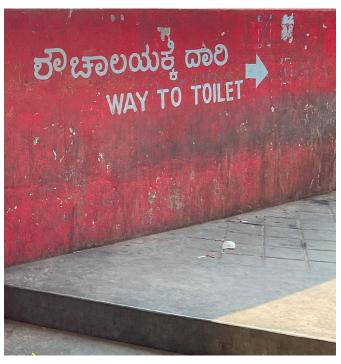
Directions to the toilet in local language and English, without universal symbols.

- 1. Route Maps and Signages: It is recommended to implement improved route maps and signage, within or around public toilet spaces, facilities can significantly enhance accessibility, aiding individuals in navigating the space more efficiently.

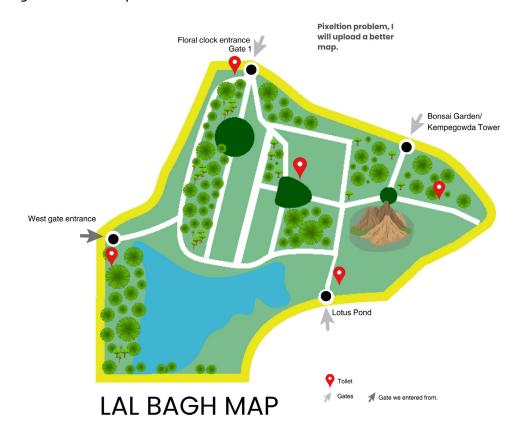
In Lal Bagh, despite the presence of five toilets, none of them were depicted on the map provided at the entrance. Consequently, individuals in need of a public toilet must navigate the park to locate one, resulting in an average search time ranging from seven to 19 minutes. This duration may vary depending on the number of inquiries a person is willing to make, as seeking guidance can expedite the search process. Notably, although route maps are available within Lal Bagh, they are positioned in such close proximity to the toilets that their utility is diminished. Upon encountering a route map, toilets are already within sight of the individuals, rendering the maps redundant for facilitating navigation.

A map depicting the location of toilets in Lalbagh.

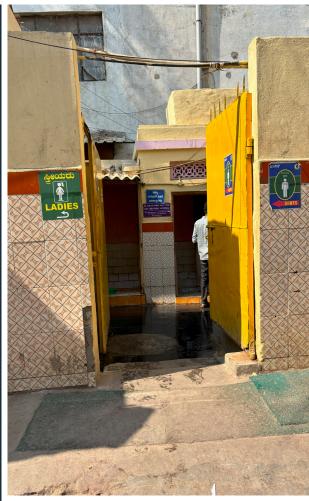
A public toilet in Chickpete, with universal symbols in green color affixed on the walls outside.

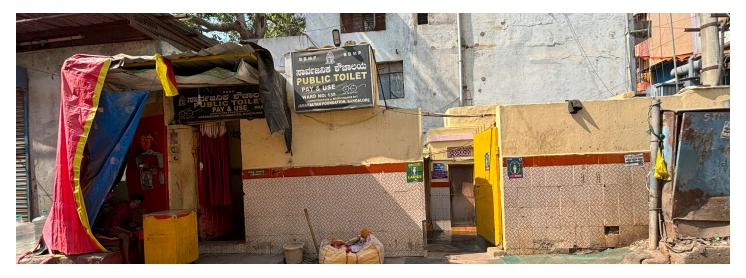
A pay-and-use toilet in Chickpete, with one female area situated between two male areas. The male staff member is sitting outside one of the male toilets on the left side.

- 12. Controlled Entry Points: It is recommended to reassess the one-point entry design as followed in Bengaluru and have different entry points for all genders. Implementation of such a controlled entry point layout with security measures such as access control systems or turnstiles to regulate the flow of individuals entering and exiting the facility, helps in enhancing the overall privacy and security within the premises.

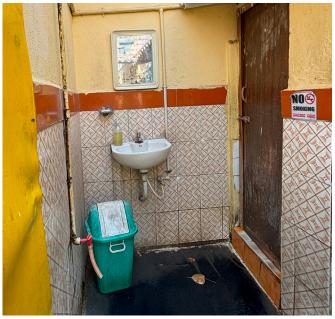
A locked and non-functional stall in one of the public toilets, situated on an elevated platform. The general area also has big-sized dustbin a mirror at an elevated level

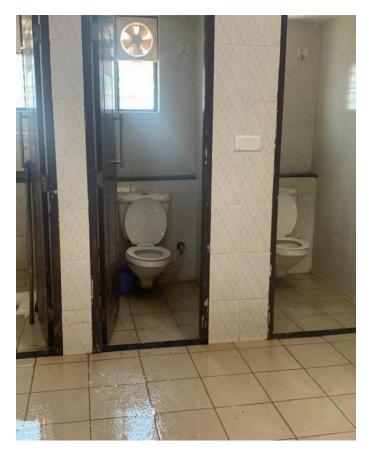
A public toilet in Cubbon park consisting both sit down and western styles of toilet, with a slippery floor and a non functional light bulb.

- **10. Lighting:** It is recommended to install adequate lighting, inside and outside the premises, particularly in secluded or dimly lit areas, to improve visibility and deter potential security threats. Utilising motion-sensor lighting would also enhance security and reduce the energy consumption.

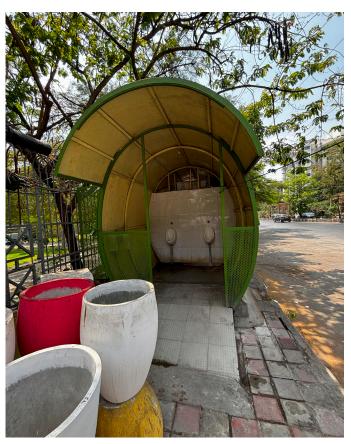
An open urinal for both males and females near Nexus mall, Kormangala.
